7/17/06

MONTANA AVIATION SYSTEM PLAN
2006 UPDATE - PAVEMENT CONDITION INDEXES

DAWSON COMMUNITY AIRPORT

GLENDAIVE
MONTANA

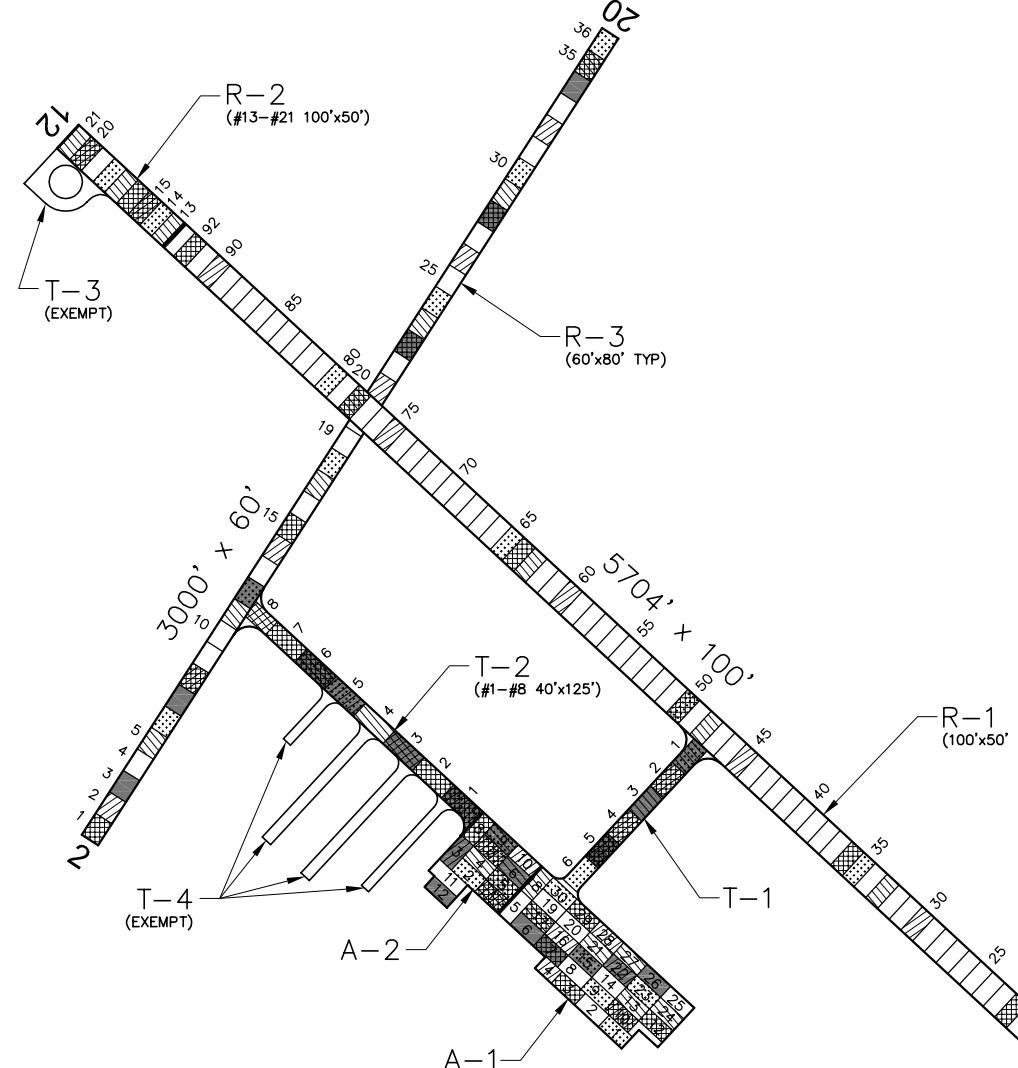
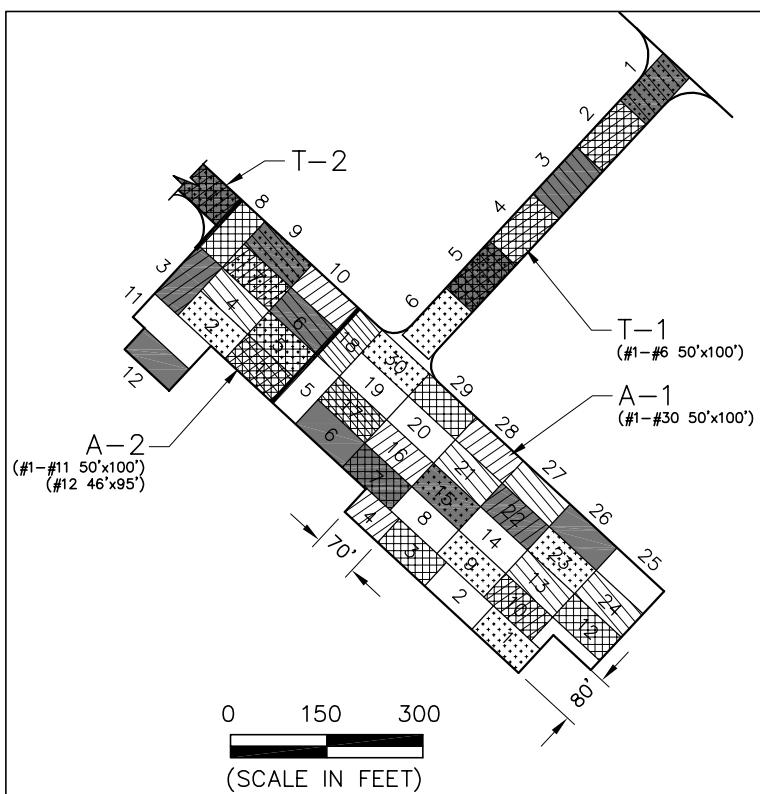
PAVE. IDENT.	SOIL CLASS	SUB GRADE CLASS	SUBBASE COURSE	BASE COURSE	SURFACE COURSE	OVERLAY	PAVEMENT STRENGTH			REMARKS
							SINGLE	DUAL	DUAL TAN.	
RUNWAYS										
R-1	E-6	F6	6" GRAVEL	6" CR. AGG.	4" AC	1" P-402,P-609	53,000	70,000	100,000	5
R-2	E-6	F6	5" GRAVEL	5" CR. AGG.	3" AC	1" P-402,P-609	38,000	50,000		5
R-3	CBR=5				6" P-208	3" P-401	2" P-401	12,500		6
TAXIWAYS										
T-1	E-6	F6	6" GRAVEL	6" CR. AGG.	4" AC	P-609	44,000	60,000	100,000	5
T-2	E-6	F6			5" AC	2.5" P-401	12,500			5
T-3	E-6	F6			5" AC	1" P-402	4,000			
T-4	CBR=5		6" P-152	6" P-208	3" P-401	2.5" P-401	12,500			4,5
APRONS										
A-1	E-6	F6	6" GRAVEL	6" CR. AGG.	4" BIT.	2" P-401	44,000	60,000	100,000	6
A-2					5" AC	2.5" P-401	12,500			5

ADAP 03-R-1, T-1, A-1, ALL HEATER SCARIFIED AND CHIP SEALED.
CBR=7 ASSUMED UNLESS OTHERWISE NOTED.
